## SHORT COMMUNICATION

### Cross-Threaded Internal Dental Implant Surface- A technical note!

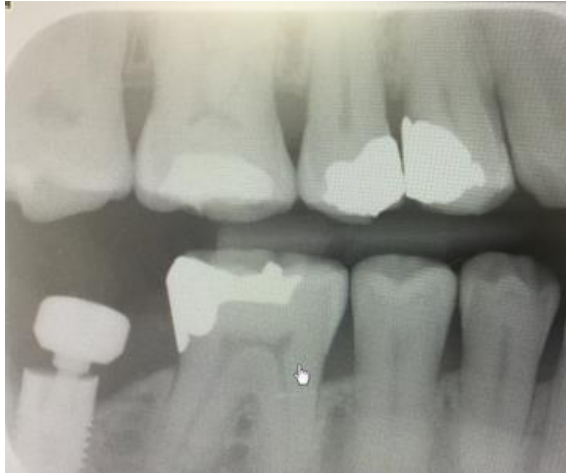
cover screw uncovering visit, an attempt to fit a healing abutment to prepare the gingival tissue was unsuccessful. Periapical radiograph was verified during multiple attempts to seat the healing abutment with no success. The inner 1/3<sup>rd</sup> thread of the implant was not permitting the complete seating of the healing abutment screw. The cover screw that was previously seated all the way through, when re-attempted resulted in failure to be re-seated. A verification radiograph confirmed possible internal thread damage was more likely the cause of non-fitting of implant healing abutment.

Fig 1a. Healing abutment mesial inclined and unable to be seated completely.

A dilemma arose debating the options for providing a definitive restoration. After analyzing multiple management options, we decided to use an innovative re-tapping tool manufactured by the Implant company to handle such complications. A Zimmer OMNI/ SPL TAP 0493 (*Zimmer Dental*) specifically designed and created for re-tapping or re-threading the internal surface of Tapered Screw- Vent Implant. This special tool had to be requested from *Zimmer Dental* to salvage the osseointegrating endosteal implant. The tool was similar to a hand driver and was inserted into the internal thread surface and seated at appropriate angle in line to the thread pattern. A clockwise 1/8<sup>th</sup> of a hand turn was performed, followed by copious irrigation of saline and adequate suction to remove the debris from the internal implant surface<sup>1</sup>.

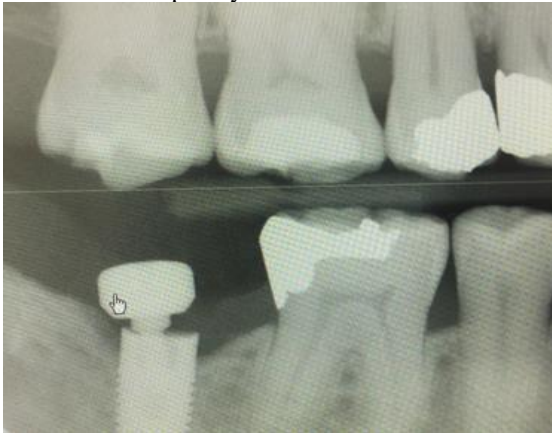
Fig 1b. Healing abutment attempted but distally inclined and unable to be seated completely.

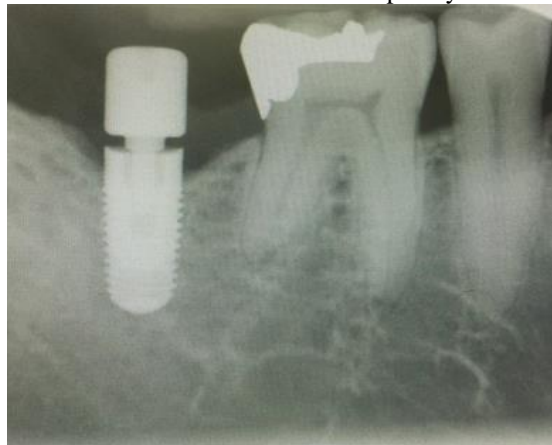
Fig 1c. Taller healing abutment attempted and unable to be seated.

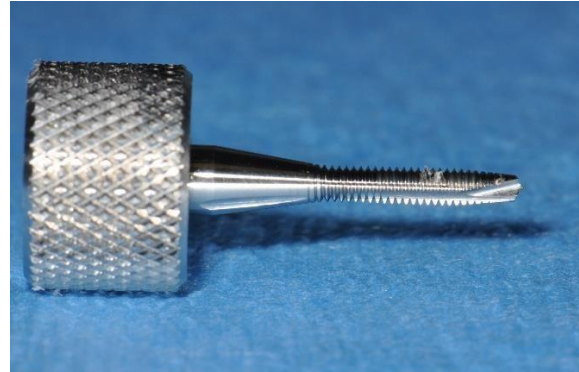
Fig 2a. Zimmer OMNI/ SPL Tap Thread hand driving tool, Zimmer Dental, USA

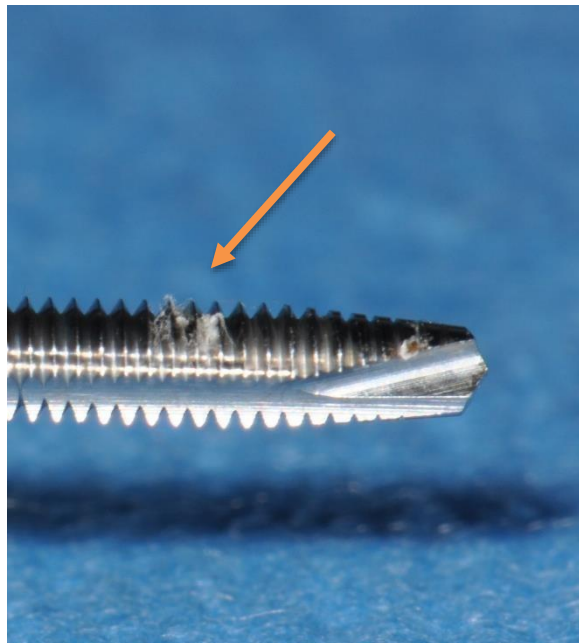
Fig 2b. Magnification (*arrow*) depicting the area on the Zimmer OMNI/ SPL tap where the successful re-threading of the distorted internal thread was accomplished.

Following the completion of re-threading or re-tapping procedure, we were able to successfully seat the new healing abutment until there was no space between the implant platform and collar of the healing abutment.
