ANALYSIS OF THE PERFORMANCE OF TIE-RODS ANCHORED IN COHESIVE SOILS, THROUGH THE NUMBER OF INJECTION STAGES

Abstract

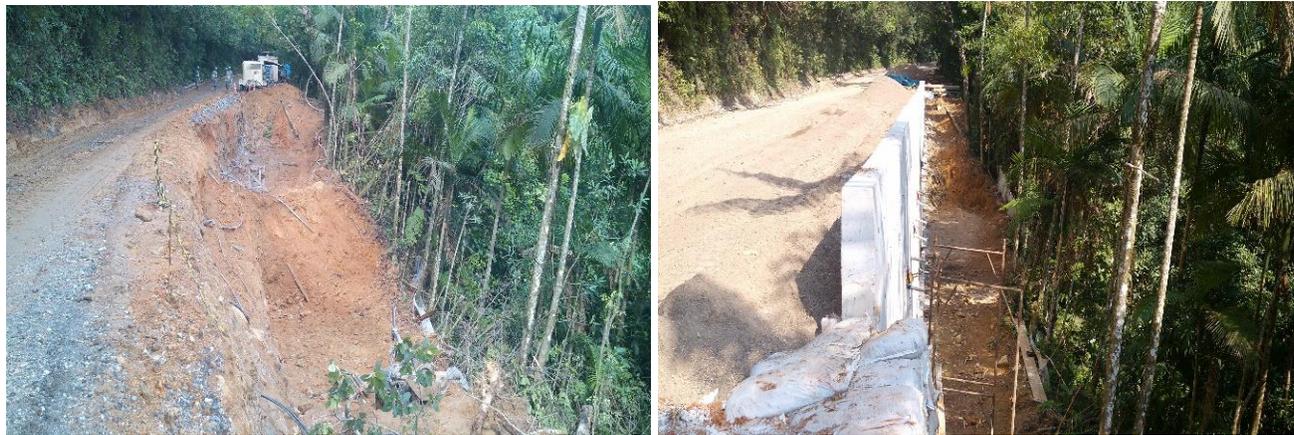
Figure 2. (a) General view of slippage, (b) General view of hillside recovery with curtains.

With a length of 35 km the Park Road was built next to the ecological park, in order to ensure environmental preservation and sustainability of the region, but due to several sections resulting from landslides, ecotourism in

the region was harmed (Figure 2a), and the work was considered emergency criteria. The slope stabilization was performed along the environmental reserve in the assessed risk sections, through the technique of curtain wall (Figure 2b) associated with drainage system.

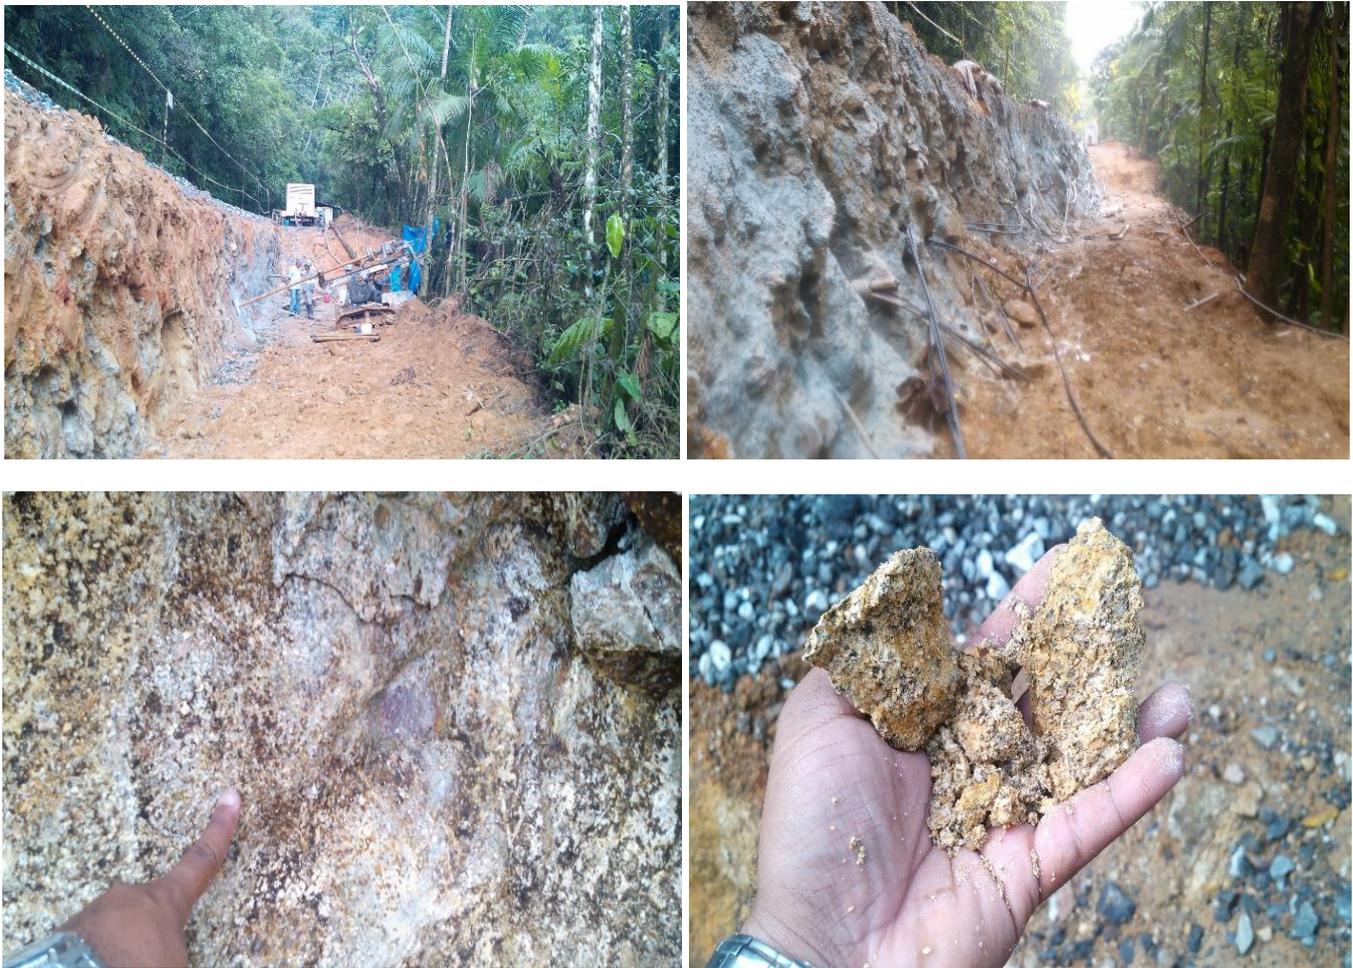
Figure 3. Geological characteristics of the area of execution of the cable stayed curtain.

The thin layer of residual soil of São Miguel Arcanjo, in general is rich in fine and medium silty sand very compact with presence of mica, or clayey silt of hard to very hard consistency with boulders, Figure 3 indicates the local geological characteristics.

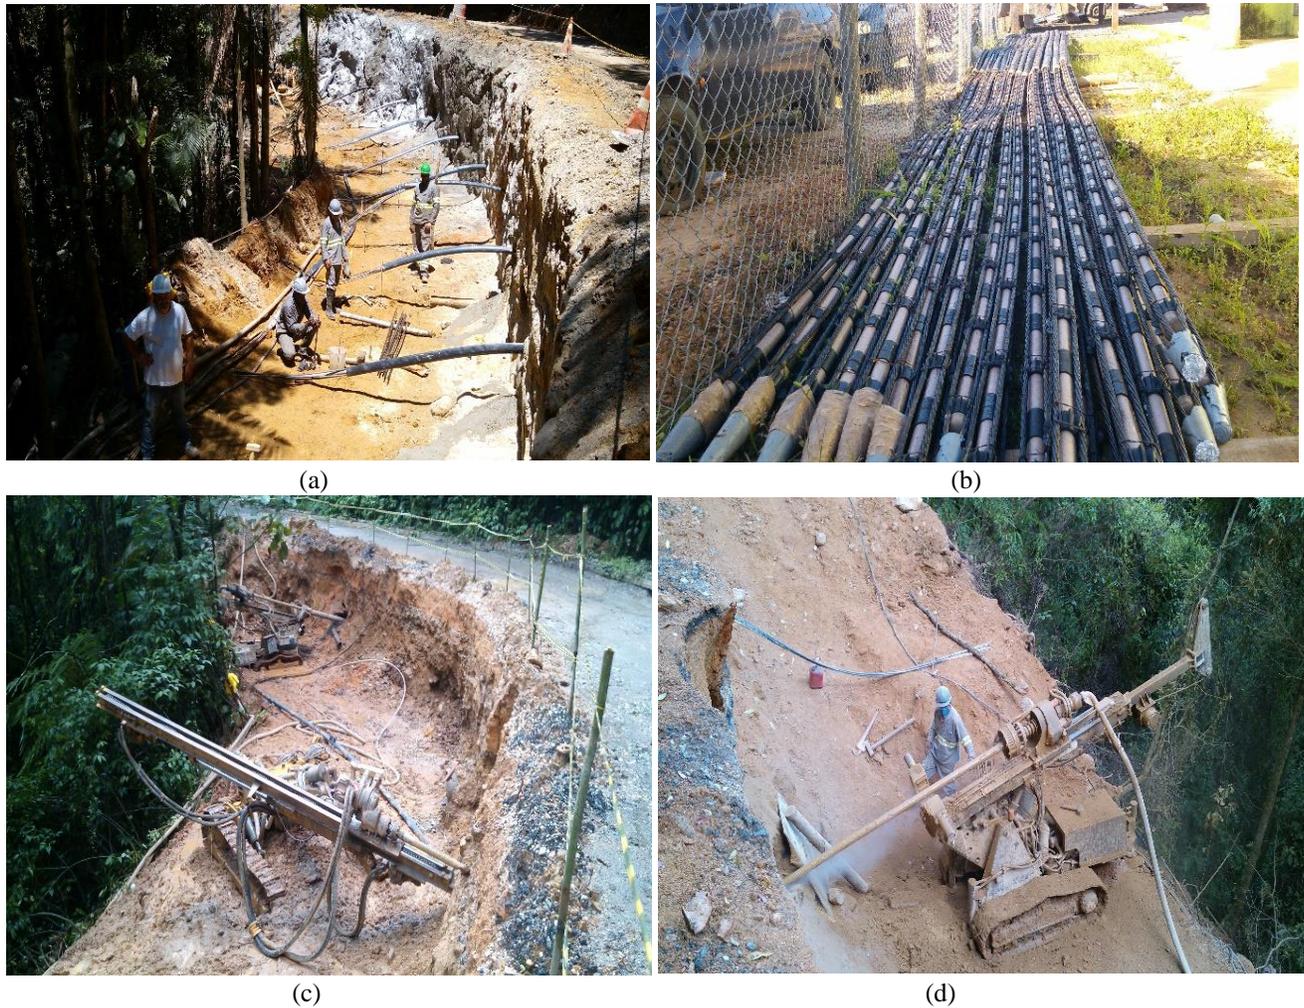
Figure 4. (a) Tie line, (b) overview detail of tie line, (c) detail of machine supported on berm, (d) drilling with compressed air.

After the slips all debris mass was removed until the stable soil layer, the ties were executed in a downward manner in two lines with a 15 degree inclination in relation to the final lay out of the slope cut at 90°, and 16 m long (Fig. 4a), 8 m anchored and 8 m free with 4 ropes of 12.7 mm, with 16 manhole valves in the anchored section spaced every 50 cm (Fig. 4b).

The drilling was performed with machines supported on 4 m berms (Figure 4c), with cleaning of the hole using compressed air to avoid its closure and environmental damage (Figure 4d), because the initial test drilling with water caused the hole to close, contributing to the increase of the existing saturation of the rock mass, promoting sliding of the slope, making it impossible to insert the tie-rods, besides the mud generated during drilling damaging the environment through the springs and native vegetation.

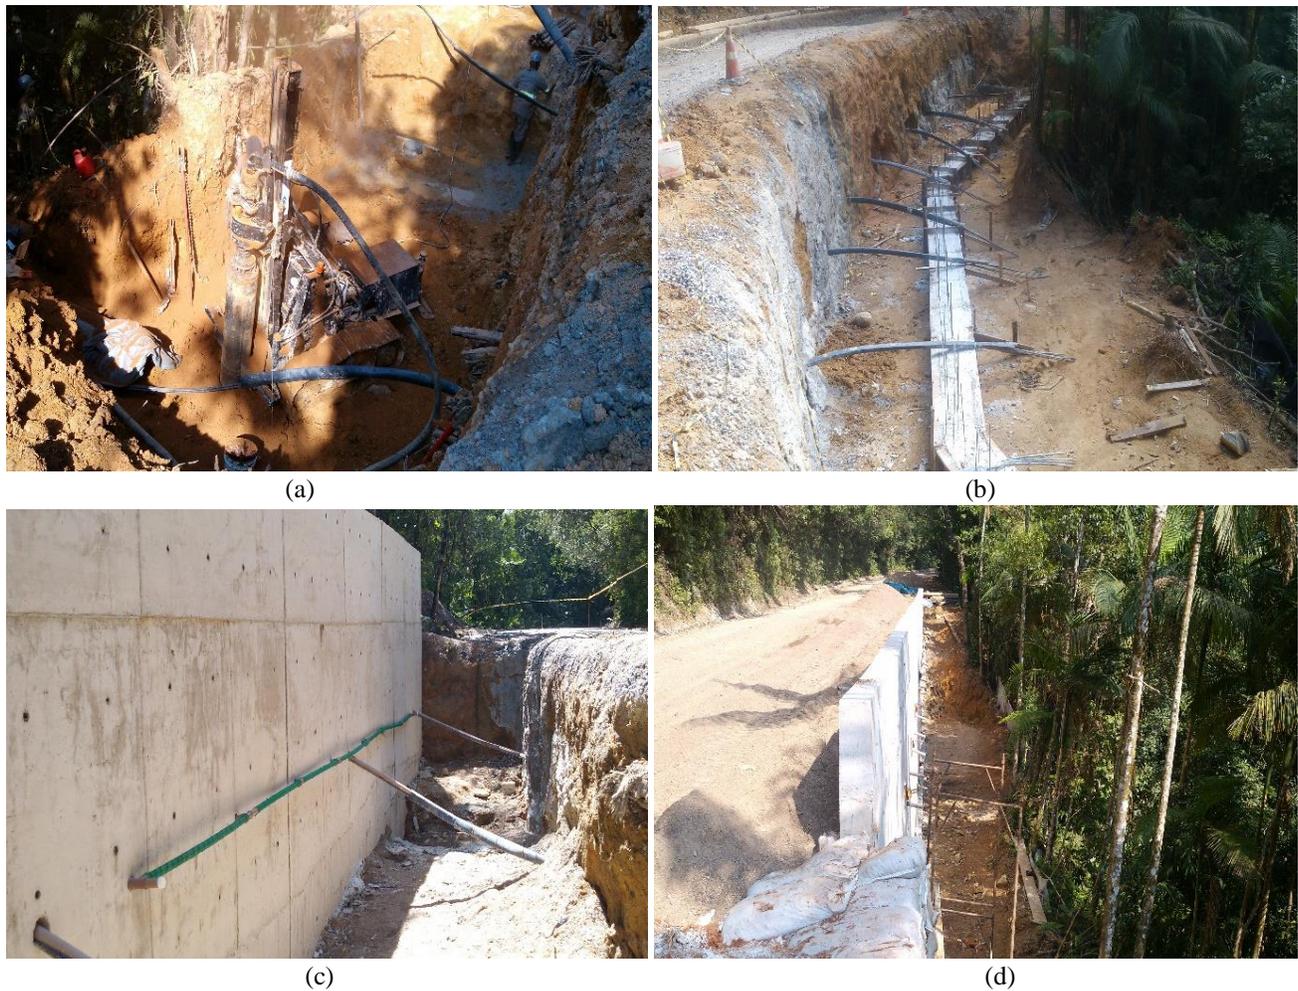
Figure 5. (a) execution of the root pile, (b) general view of the ties incorporated into the curtain, (c) detail of the drainage system, (d) geometry of the track reconstituted with sand.

After the execution of the tie-rods, root-type piles were executed as foundations of the cable stayed curtain (Figure 5a), and the original geometry of the slopes were maintained, leaving about 3 m of free stretch of tie-rods, incorporated during the concreting of the panels (Figure 5b), the drainage system behind the curtain were

interconnected to barbacans (Figure 5c), The drainage system behind the curtain was connected to barbs (Figure 5c), enabling the removal of water from the embankment by throwing and vibrating medium coarse sand to reconstruct the roadway (Figure 5d).

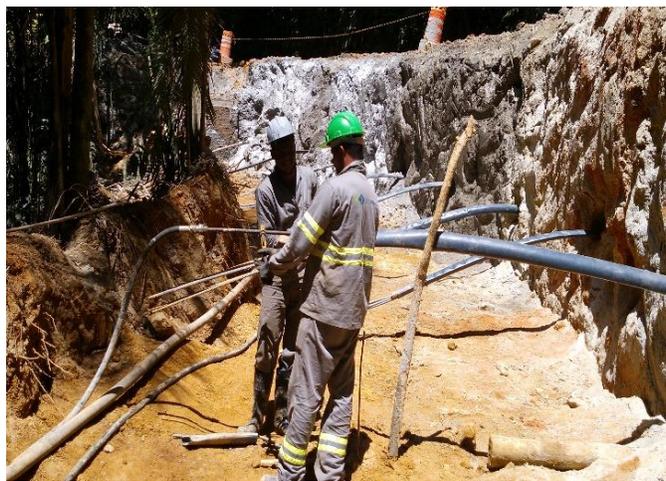
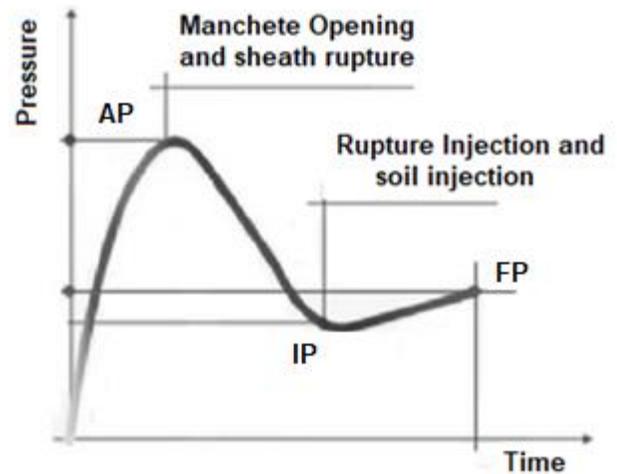
Figure 6. (a) General view of tie rod injection, (b) Detail of tie rod injection pressure.

a/c 0.5 and mechanical resistance at 28 days with values between 25 and 28 Mpa. The injection pressures and grout volume absorbed for all the gate valves were monitored through a pressure stabilizer installed near the injection center, depending on the grout behavior regarding the injectability in the rock mass, the opening pressures (AP) varied from 25 to 45 kgf/cm², and injection pressures (IP) averaged 30 kgf/cm², thus the number of injection stages was performed according to the injectability of the soil around the anchors, carried out after a period of 24 hours (Figure 6a). The interruption of the injection stage for each headline valve was performed when the values of the final pressure (FP) exceeded the values of the injection pressure (PI), enabling the development of the anchorage bulb (Figure 6b).

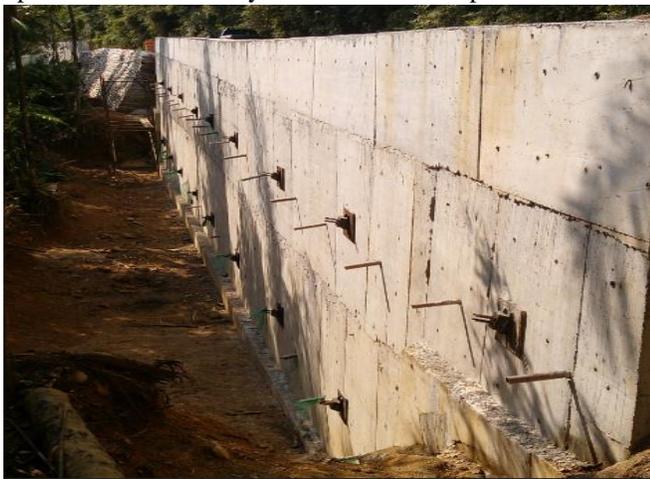
Figure 8. (a) General view of the curtain of tested tension specimens, Reception tests tension specimens: (b) 1st injection stage, (c) 2nd injection stage, (d) 3rd injection stage.

According [8], to evaluate the load capacity and behavior of the tension specimens, acceptance tests were performed with a maximum load of 1.40 (Ft), in a curtain with 21 tension specimens according to Figure (8 a), with a working load of 40 tf, evaluated in batches with different stages of injections as indicated in Table 1. The receipt test is made from the application of a cycle of pre-defined loads and the readings of displacements of the tie head during loading and an unloading in the last stage of the cycle. The presentation and analysis of the tests are performed after
