CASE REPORT

Implant fixture fracture related to angulation path compounded by implant width – A case report.

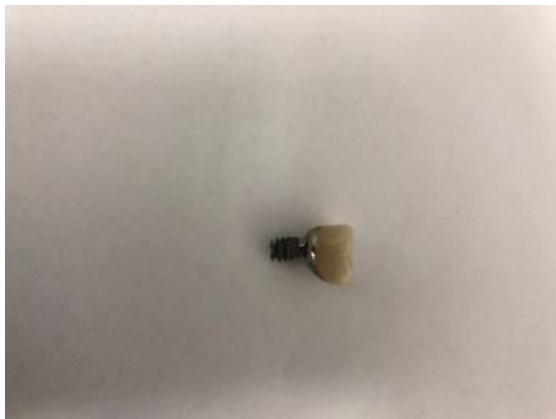
Figure 1: Clinical photograph of fractured coronal portion of implant fixture with porcelain restoration

In March 2018, patient returned to the periodontist with complaints of a "loose crown" in the area of previously placed implant fixture. The implant-restoration unit was tightened with an implant wrench to 35 Newton-centimeters, to address the problem. The implant-restoration unit was then deemed stable and patient was discharged with a serviceable implant-crown in the region of tooth #30. Patient, however, returned to the periodontist office on May 8, 2018 with the crown and portion of the implant fixture completely avulsed from tooth #30 region. On radiographic examination, it was confirmed that the implant fixture had fractures at the apical-third level and, therefore, had dislodged the implant fixture with the restoration portion. At this juncture, the periodontist, after discussing and obtaining appropriate consent from the patient, decided to opt for corrective treatment with

reference to the implant-restoration unit. The periodontist decided to remove the fracture segment of the implant fixture that was lodged in the alveolar bone in the region of tooth #30 and place a new NobelActive implant fixture with an appropriate width and height of 5.5 mm and 10.0 mm, respectively.

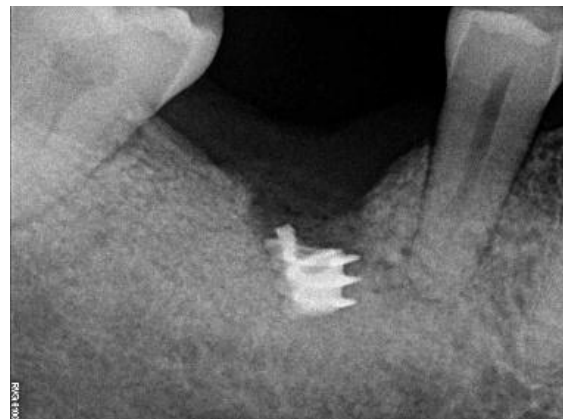
Figure 2: Intra-oral periapical radiograph showing fractured residual fragment of implant fixture which was removed completely

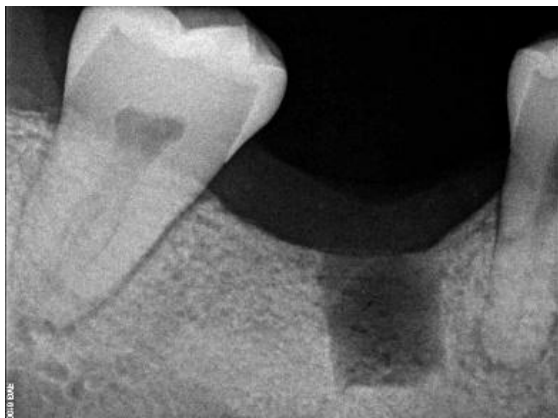
Figure 3: Intra-oral periapical radiograph showing site of explanted implant fixture

On May 22, 2018, the periodontist proceeded to surgically remove the fractured implant fragment by removing bone (“guttering”) around the fractured implant with a Trepphine bur. An implant fixture with modified dimensions was secured in place within bone and closed with a cover screw. A healing abutment was placed over the implant fixture in September 2018. The implant fixture was again restored by a general dentist in November 2018 and the implant-restoration unit has been in function and serviceable continuously since then, without interruption and any untoward incident. Patient was satisfied with the outcome of the treatment done the second time around and has not reported any symptoms from the implant-restorative until till date.

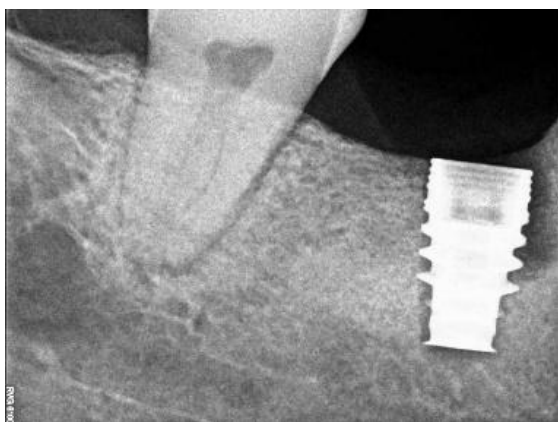
Figure 4: Intra-oral periapical radiograph replacement implant fixture with new dimensions after removal of fractured implant fixture
